Gigabit Interface

PI5 Overview

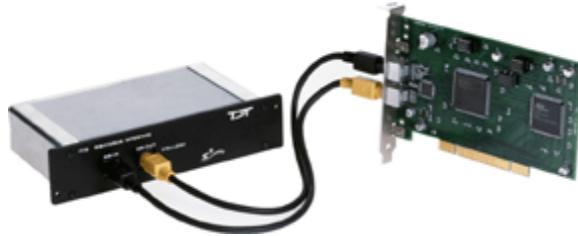
The Gigabit system is no longer available. It consists of a PCI card (PI5) that fits in the computer and one or more GBit-to-zBus interface modules (FI5) that mounts in the rear slot of a zBus device chassis. Devices are connected in a simple loop using provided cabling. When using the gigabit-interface all devices (across all chassis) are automatically phase locked to a single clock. Over 100 devices can be connected in a single Gigabit loop with automatic device identification and system initialization.
